NEW ZEALAND AGRICULTURAL AVIATION

SAFETY UPDATE

SEPTEMBER 2019

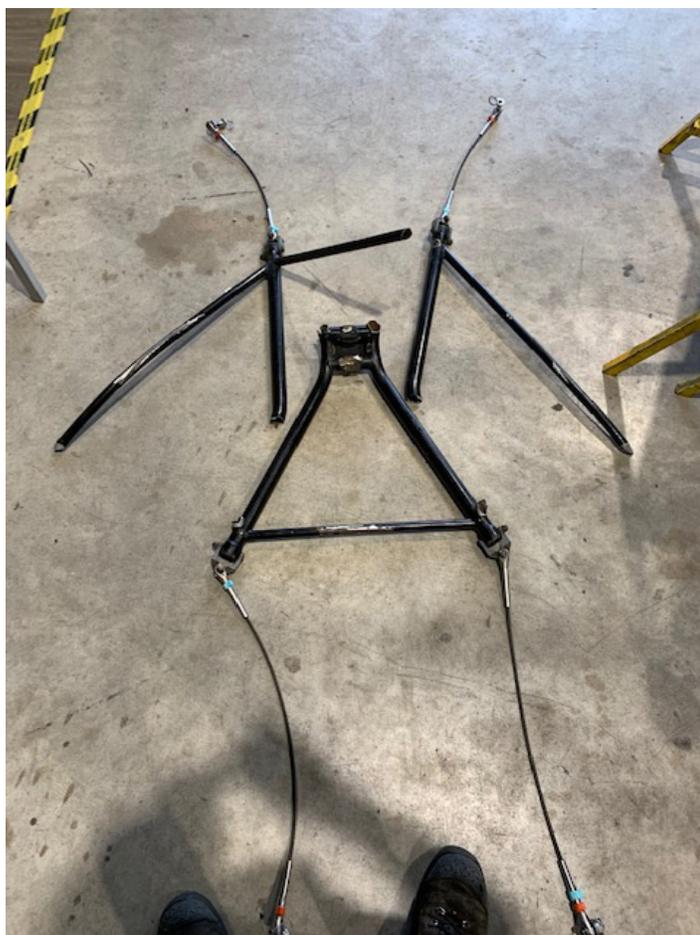
Pilot reported was carrying out Ag operations when he heard a loud noise and noticed his fertiliser bucket had detached from the aircraft, the pilot landed immediately and found the cargo hook frame in 3 pieces. The cargo hook frame has been inspected, the cause is yet to be confirmed. The cargo hook frame assembly was replaced.

Image of the cargo hook frame.
