Slope Failure in a Complex Volcanic Terrain Opito Bay, Kuaotunu, Coromandel Peninsula

Steven Price – Riley Consultants Ltd, Auckland

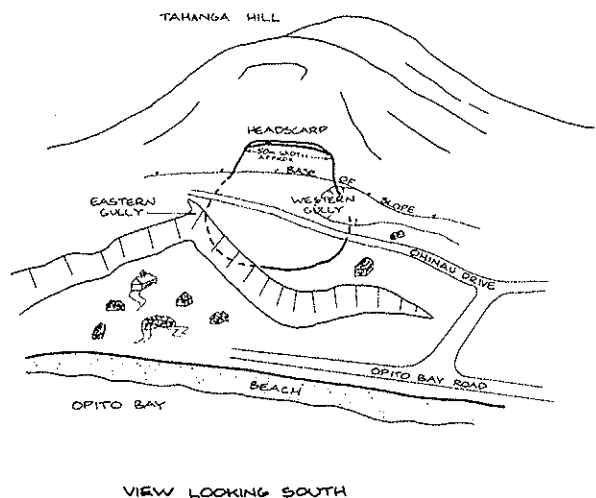
Figure 2 – Perspective View

The Ohinau Drive slide is located at Opito Bay in the eastern extent of Kuaotunu Peninsula, north eastern Coromandel Peninsula. (Figure 1) The slope failure has developed largely beneath vacant lots of a recent subdivision extending southward into a Pine plantation covering Tahanga Hill (Figure 2).

It included an unexpected movement in one survey mark at the centre of a quite deep local gully (labeled western gully in figure 2) indicative of deep seated movement sufficient to carry the whole overlying topography as a block.

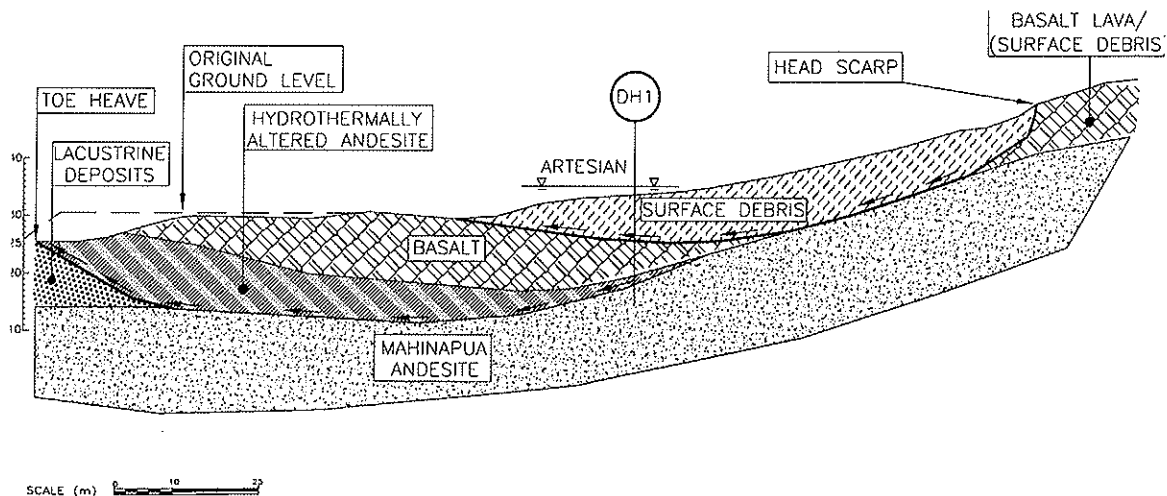
Figure 4 – Geological Cross Section of Ohinau Drive Failure

Failure surfaces are often not easily detected in recovered core however a distinct failure surface was encountered in drillhole R1 at the base of the basaltic debris where it contacts the underlying andesite consisting of a striated slickenside. A failure surface was also observed in a test pit excavated in the toe heave zone, with movement of highly weathered hydrothermally altered andesite over lacustrine deposits.

- **Surface Debris Failure**
Reactivation of ancient slip debris moving over the underlying andesite. This failure explains relatively large boundary peg movements (in the order of 0.5m) in Lots adjacent to Tahanga Hill and the development of a tension crack in the basaltic material at the base of Tahanga Hill. However, this failure mechanism does not explain the andesite toe heave north of Ohinau Drive or movement at the andesite western gully base.
- **Andesite Failure**
Deep failure within the andesite along shear zones or clay seams as identified in cores. This failure mechanism is thought to have been active in winter of 1996 and is consistent with toe heave.

Both failure surfaces are shown on Figure 4.

It is proposed to install counterfort (buttress) drains within the surface debris to minimize the risk of saturation and achieve a Factor of Safety in excess of 1.5.

Large diameter bored drains are the preferred drainage method for the andesite drilled from the slope toe. Achieving a Factor of Safety in excess of 1.5 for the underlying andesite is considered impractical given the slope gradients and depth of drawdown required. A Factor of Safety of 1.4 is the recommended objective. With no dwellings with the main movement area, nor immediately adjacent, any settlement caused by drainage is considered unlikely to affect existing structures.
