GEOTECHNICAL ASSESSMENT OF FOUNDING CONDITIONS FOR LARGE WIND TURBINES TARARUA RANGES, NEW ZEALAND

Steven Price
Riley Consultants Ltd
Auckland, New Zealand

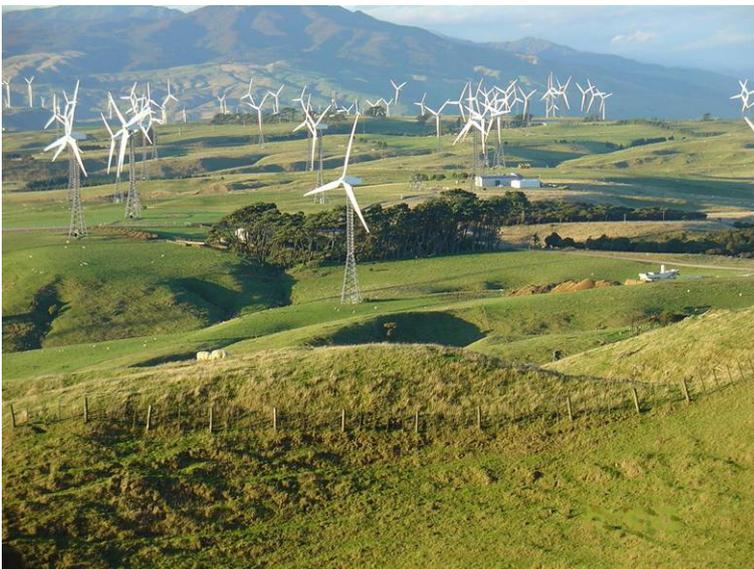
Figure 1: View of pre-existing Tararua Windfarm looking northeast.

TrustPower Ltd, a private New Zealand owned generation company, has committed to a stage 3 expansion of an existing wind farm on the Tararua Ranges, east of Palmerston North city. A general view and location is shown in Figures 1 and 2.

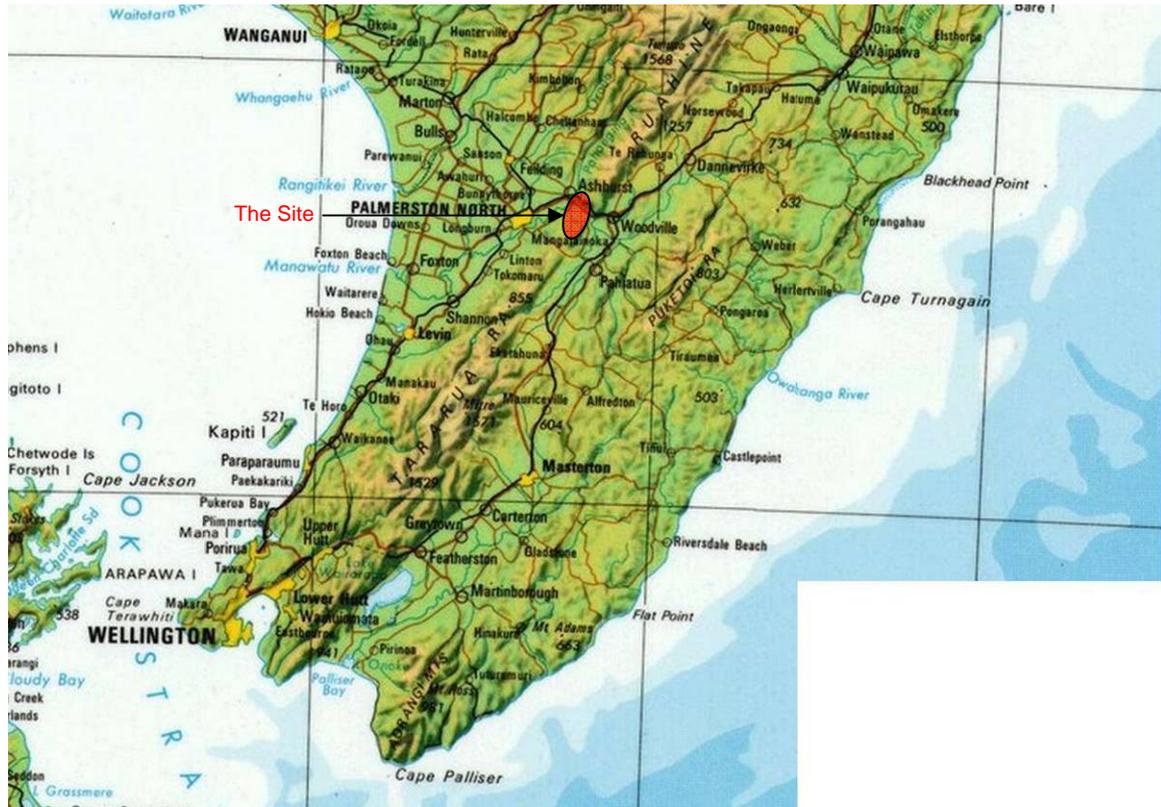
Figure 2: Location plan.

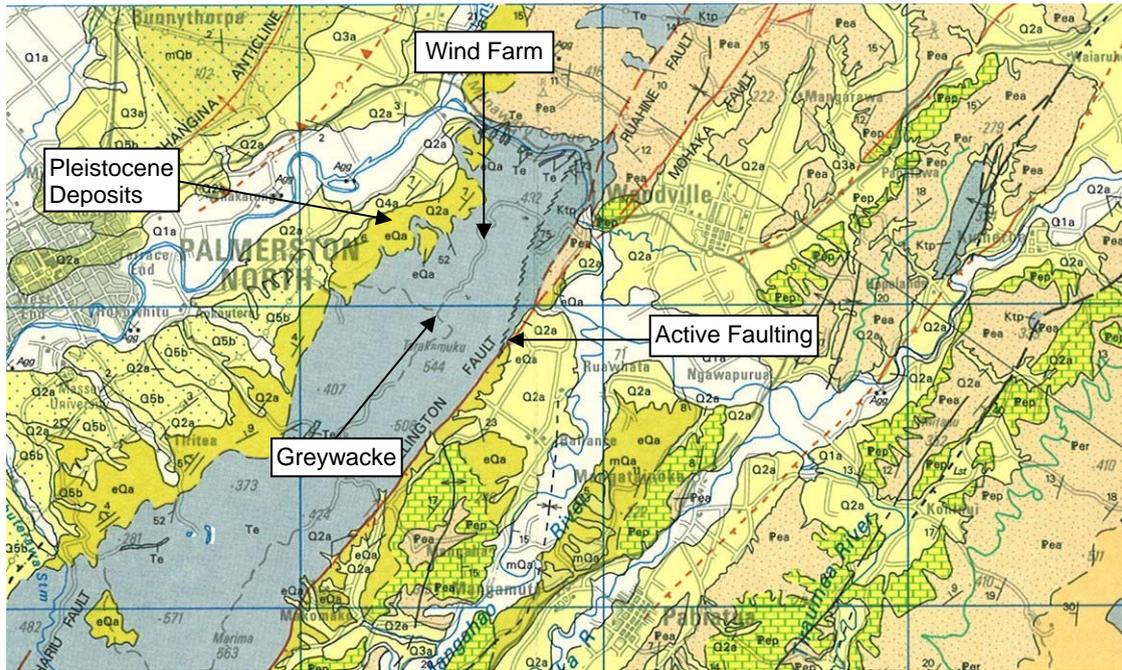
Figure 3: General geology of the TrustPower Ltd Tararua Windfarm and surrounding area. Geology encountered on site was considerably more complex than shown on large scale published plans.

The predominant material forming the Tararua Ranges is Mesozoic age greywacke sandstone and argillite. Overlying this is localised Tertiary sedimentary deposits and later Pleistocene/Holocene alluvial material forming terraces and filling gullies in older deposits. A general geological plan is shown in Figure 3.

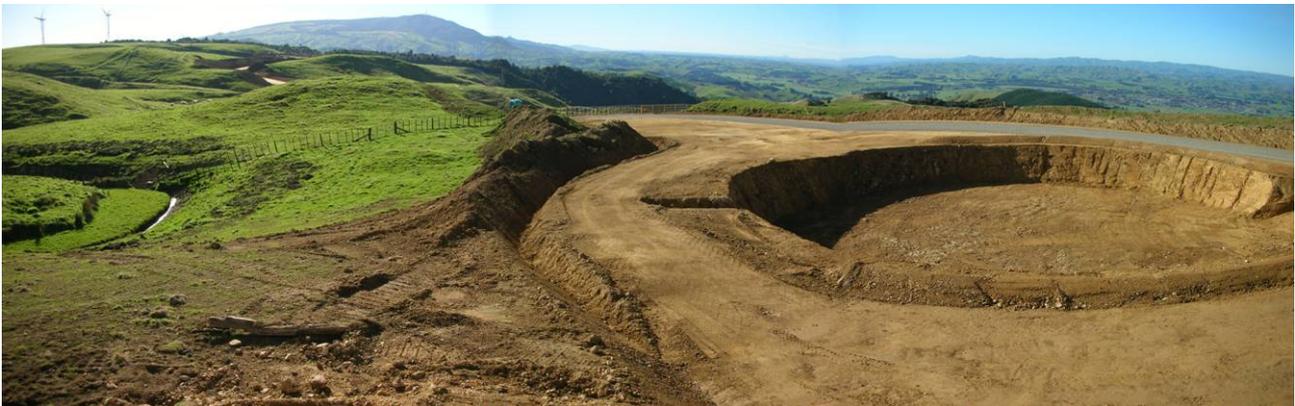
The foundation excavation exposed highly to moderately weathered, closely jointed, greywacke with no major argillite exposed. There were virtually no steep slopes in close proximity to the foundation, with the exception of a slope to the northwest of about 20° leading down to a stream (shown in Figure 4 below).

Figure 4: Site 5 foundation excavation and adjacent stream.

Mapping of major defects in the excavation and detailed measurement of joints at the northwestern corner were performed. Analysis indicated two potential wedge type failures that could daylight to the northwest. Dip of the wedges (<19°) and the nature of the defects which formed this wedge (rough, zeolite filled) indicated failure was unlikely.

Rotational and translational type failure of the northwestern slopes was also considered. Computer based stability analyses were performed indicating a Factor of Safety against instability of >1.4 under extreme conditions (generally >1.3 was acceptable under extreme conditions). Erosion of the slope toe by the stream was also considered. With a sufficient setback between the steeper slope and foundation edge it was considered enough warning time would be available to implement protection measures should erosion advance up the slope.

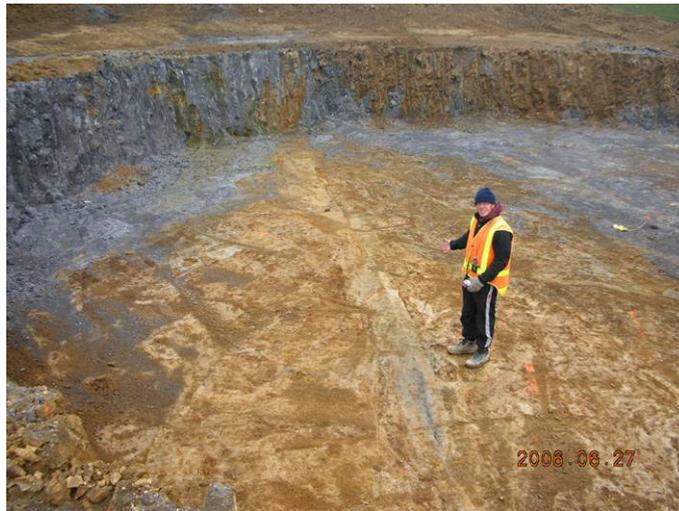
Excavation of the second hole revealed a clay pug filled lineament crossing the southern part of the foundation hole and continue through the platform in an east-west orientation (Figure 5). This feature appeared to be an off-shoot of the crush zone, or alternatively obscured in the crush zone exposed in the first hole.

Figure 5: Clay filled lineament through second foundation excavation at site 9.

Approximately 100m to the north of the site was known to be Pleistocene alluvial deposits overlying greywacke. A trench of approximately 60m in length was dug in an attempt to intercept the inferred fault and identify whether it offset the overlying alluvial deposits. The inferred fault was not encountered and careful measurement and plotting of the fault indicated it curved away to the south, avoiding the practical limits of trenching.

Detailed aerial and on-ground study of lineaments was performed. This work suggested the inferred fault was inactive as it would appear this lineament had been offset by later faulting that is now considered inactive. The presence of faults and relative periods of activity were primarily established through valley locations and offsetting of streams.

The foundation was subsequently constructed at this location. Slopes to the immediate north of the foundation were noted as being affected by past instability and considered at risk of further movement. A palisade wall was recommended along the northern edge of the foundation.

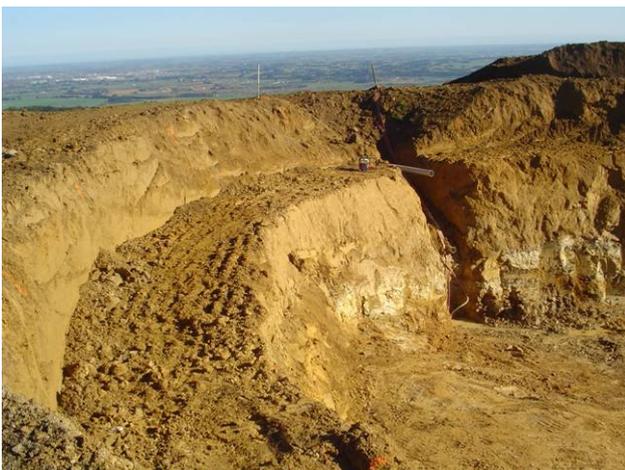
Though excavated on a ridge crest this foundation encountered inferred Holocene/Pleistocene gully alluvium and minor Tertiary sedimentary weak rock. It was evident from the excavations that an incised gully cut through the greywacke at this location. The softer alluvial deposits were undercut until very weak greywacke rock was encountered. This resulted in a relatively large undercut of up to 4m+ in the northwestern corner. The undercut was backfilled in 200mm compacted layers of AP65 crushed alluvial gravel. Figures 6 and 7 show the excavation and backfilling.

Figure 6: Site 34 excavation and undercut concrete pad. Founding level is approximately at the PVC pipe level.

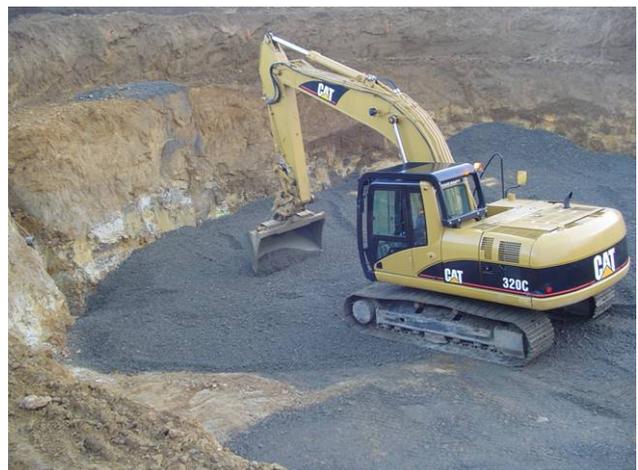
Figure 7: Backfilling of undercut at Site 34.
